The value of multiple earthquake missions: the EEFIT L'Aquila Earthquake experience

T. Rossetto · D. D'Ayala · F. Gori · R. Persio · J. Han · V. Novelli ·
S. M. Wilkinson · D. Alexander · M. Hill · S. Stephens · S. Kontoe ·
G. Elia · E. Verrucci · A. Vicini · W. Shelley · R. Foulser-Piggott

Abstract In November 2012 EEFIT launched its first ever return mission to an earthquake affected site. The L'Aquila Earthquake site was chosen as this is a recent European event of interest to the UK and European earthquake engineering community. The main aims of this return mission were to document the earthquake recovery process and this paper presents an overview of the post-disaster emergency phase and transition to reconstruction in the Aquila area after the earthquake. It takes an earthquake engineering perspective, highlighting areas mainly of interest to the fields of structural/seismic engineering and reconstruction management. Within the paper, reference is made to published literature, but also to data collected in the field during the return mission that would not otherwise have been available.

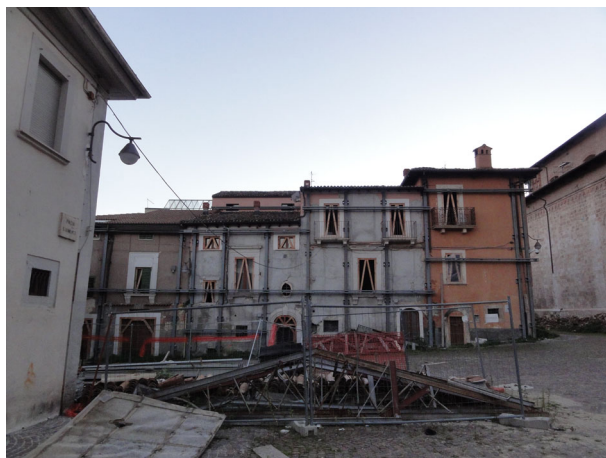
Fig. 5 Example of an aggregate: four distinct building units sharing party walls

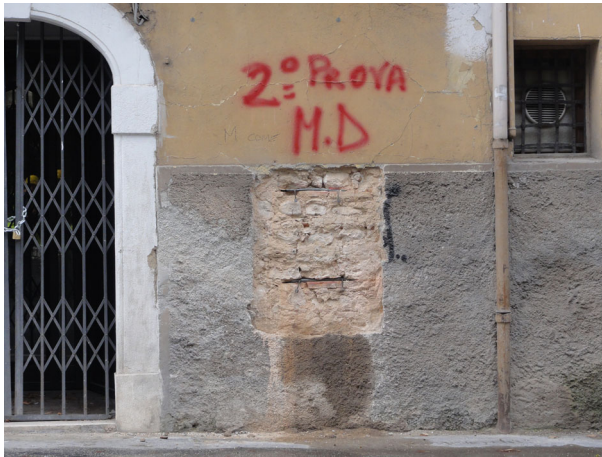
Fig. 6 Photo of typical double flat-jack test to determine compressive strength and mechanical characteristic of masonry
